Debris/Ice/TPS Assessment and Integrated Photographic Analysis of Shuttle Mission STS-83

**DEBRIS/ICE/TPS ASSESSMENT
AND
INTEGRATED PHOTOGRAPHIC ANALYSIS
OF
SHUTTLE MISSION STS-83**

4 April 1997

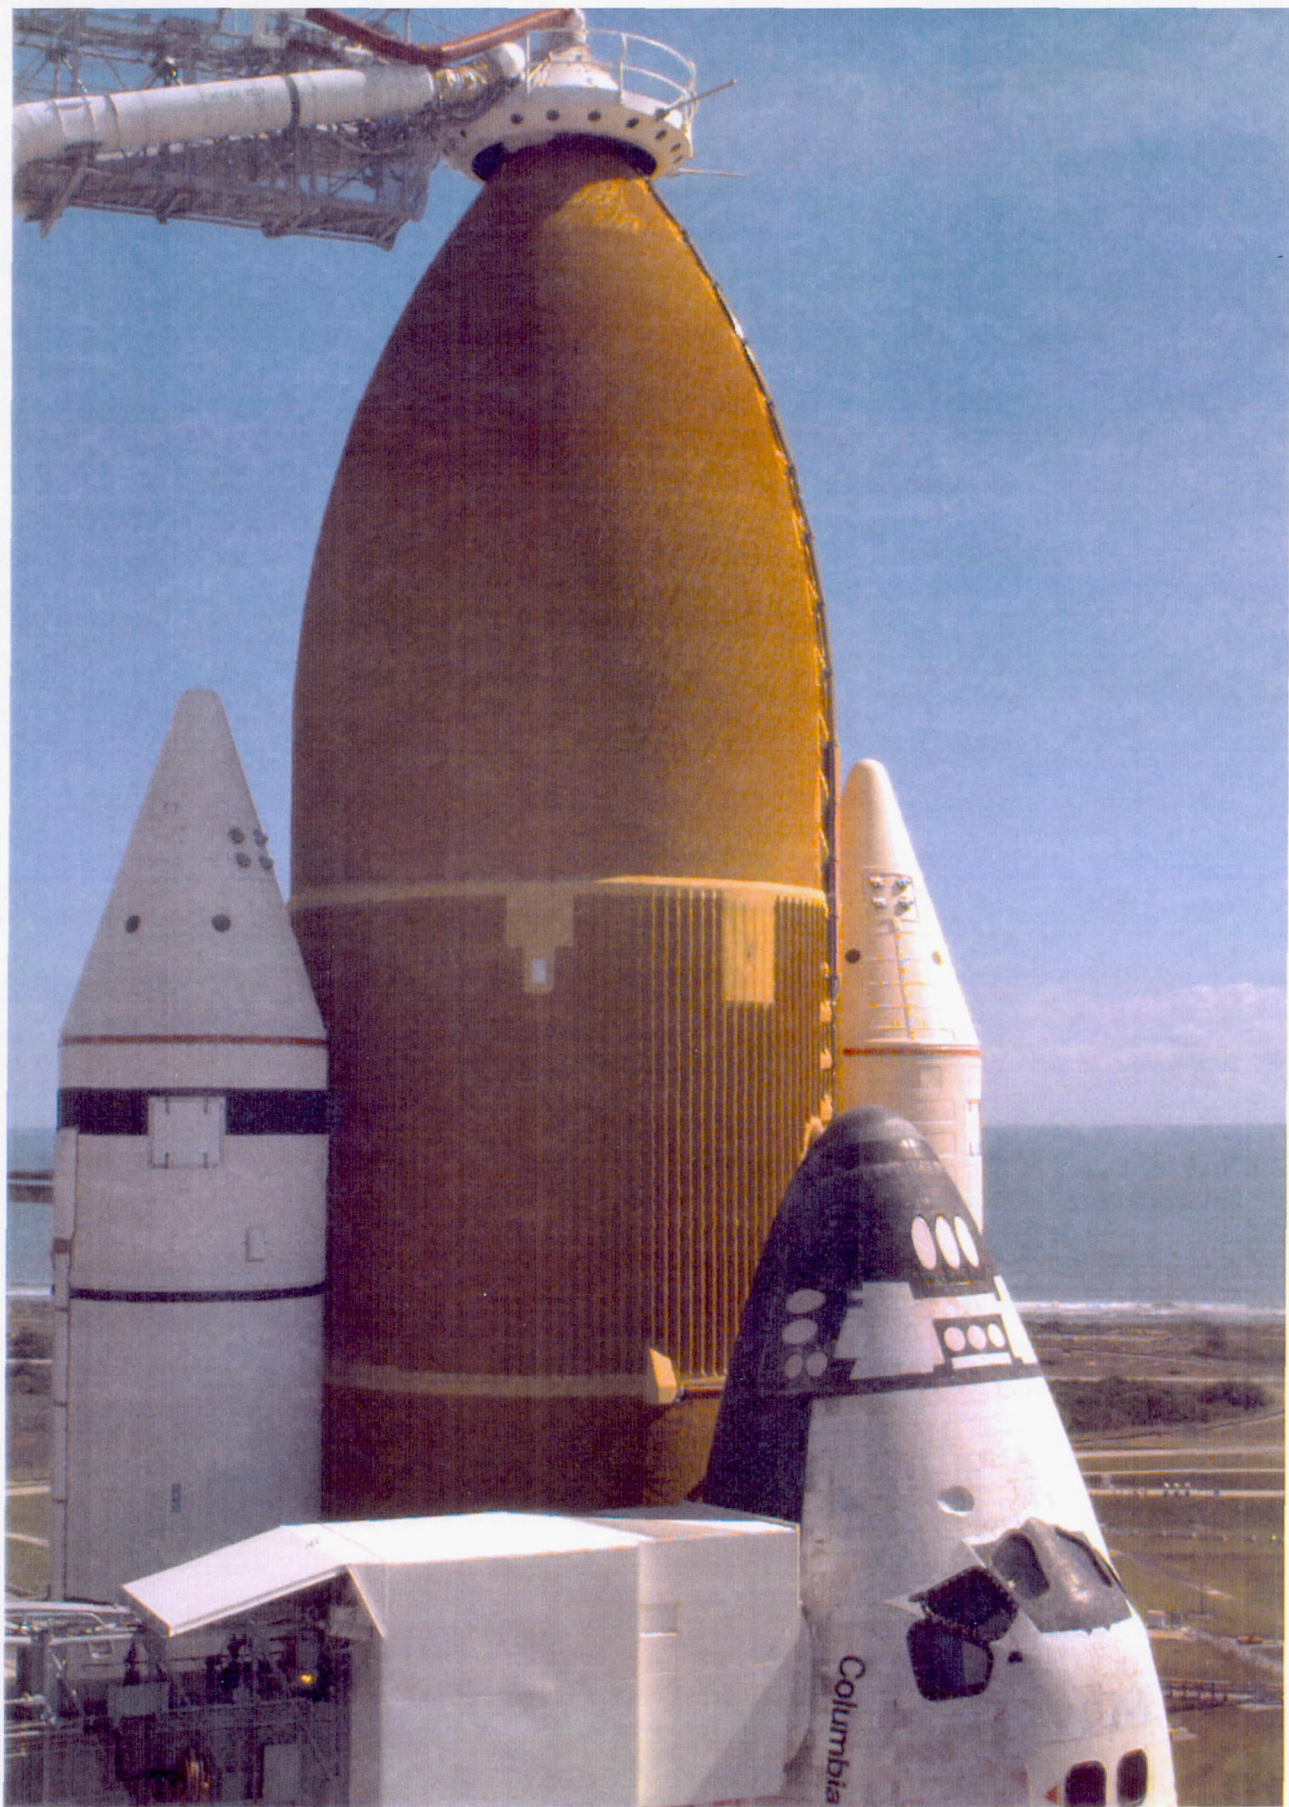
Photo 3: LO2 Tank After Cryoload

The Final Inspection Team observed no condensate, ice, or frost accumulations on the LO2 tank. TPS surface temperatures ranged from 52-62 degrees F.

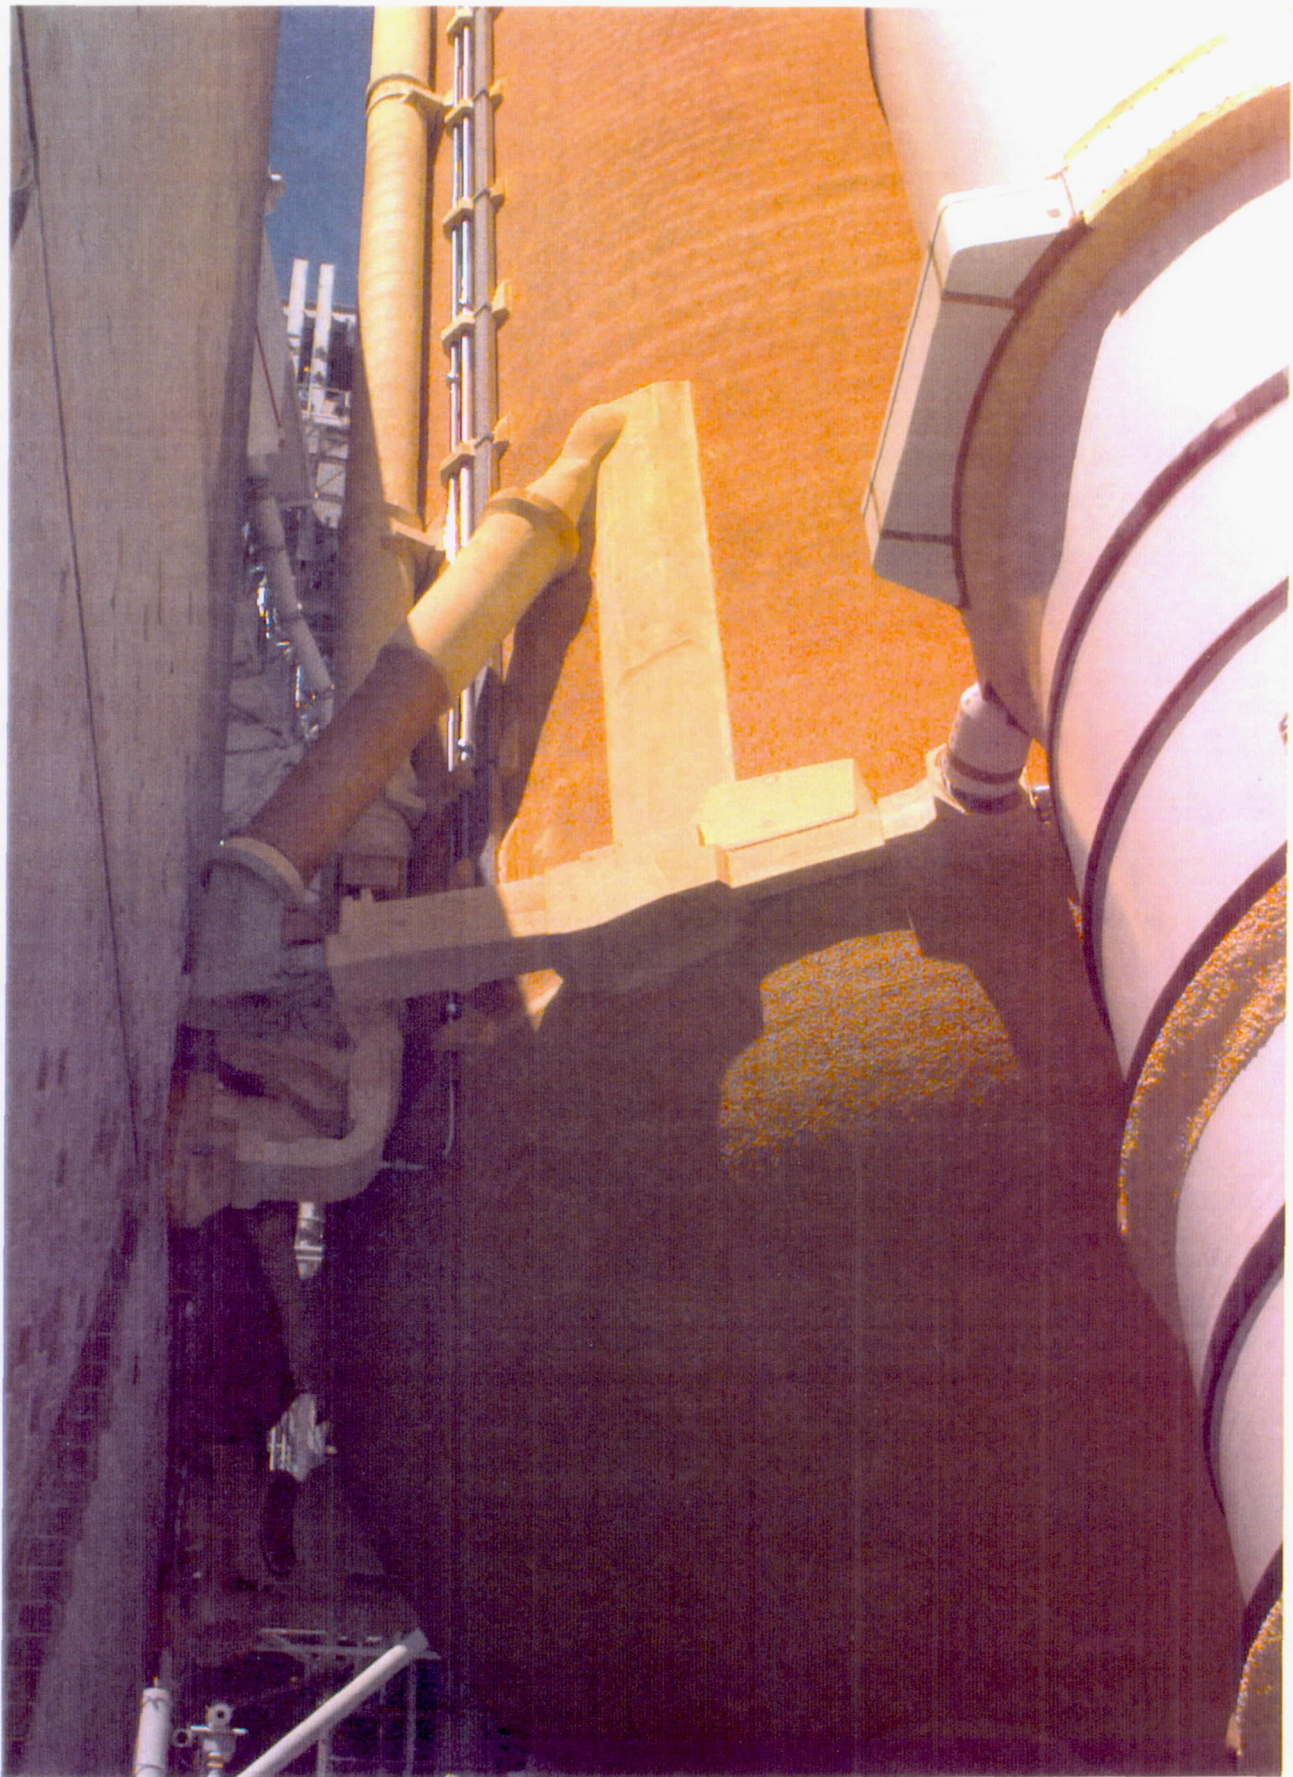
Photo 4: LH2 Tank After Cryoload

The Final Inspection Team observed no condensate, ice, or frost accumulations on the LH2 tank acreage. TPS surface temperatures averaged 52 degrees F.

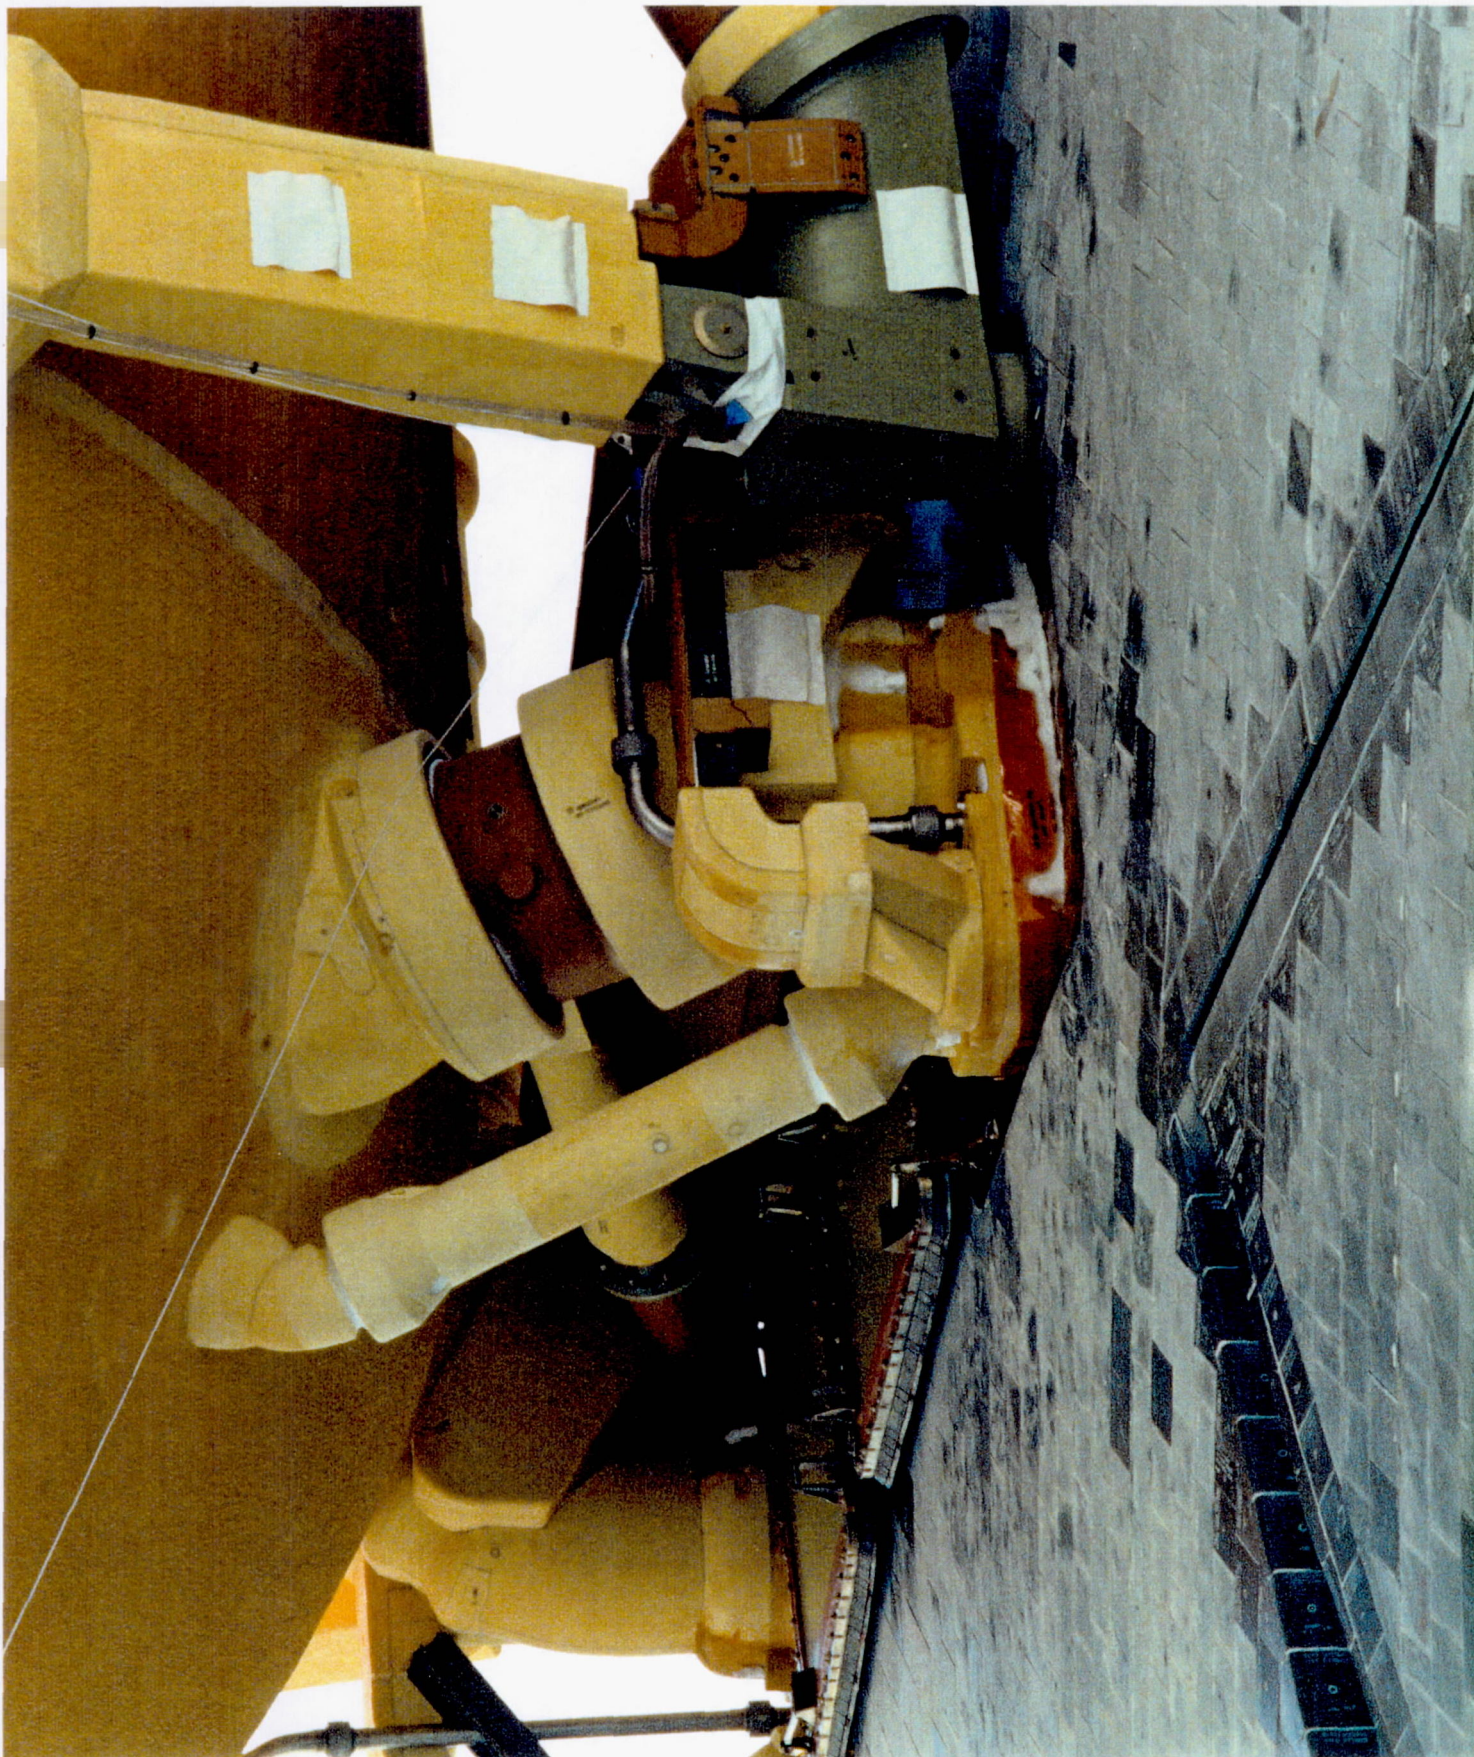
Photo 6: LH2 ET/ORB Umbilical

Less than usual amounts of ice/frost had accumulated on the LH2 ET/ORB umbilical purge barrier outboard sides, but typical on the forward surface. Smaller than usual ice/frost fingers were present on the pyro canister and plate gap purge vents.

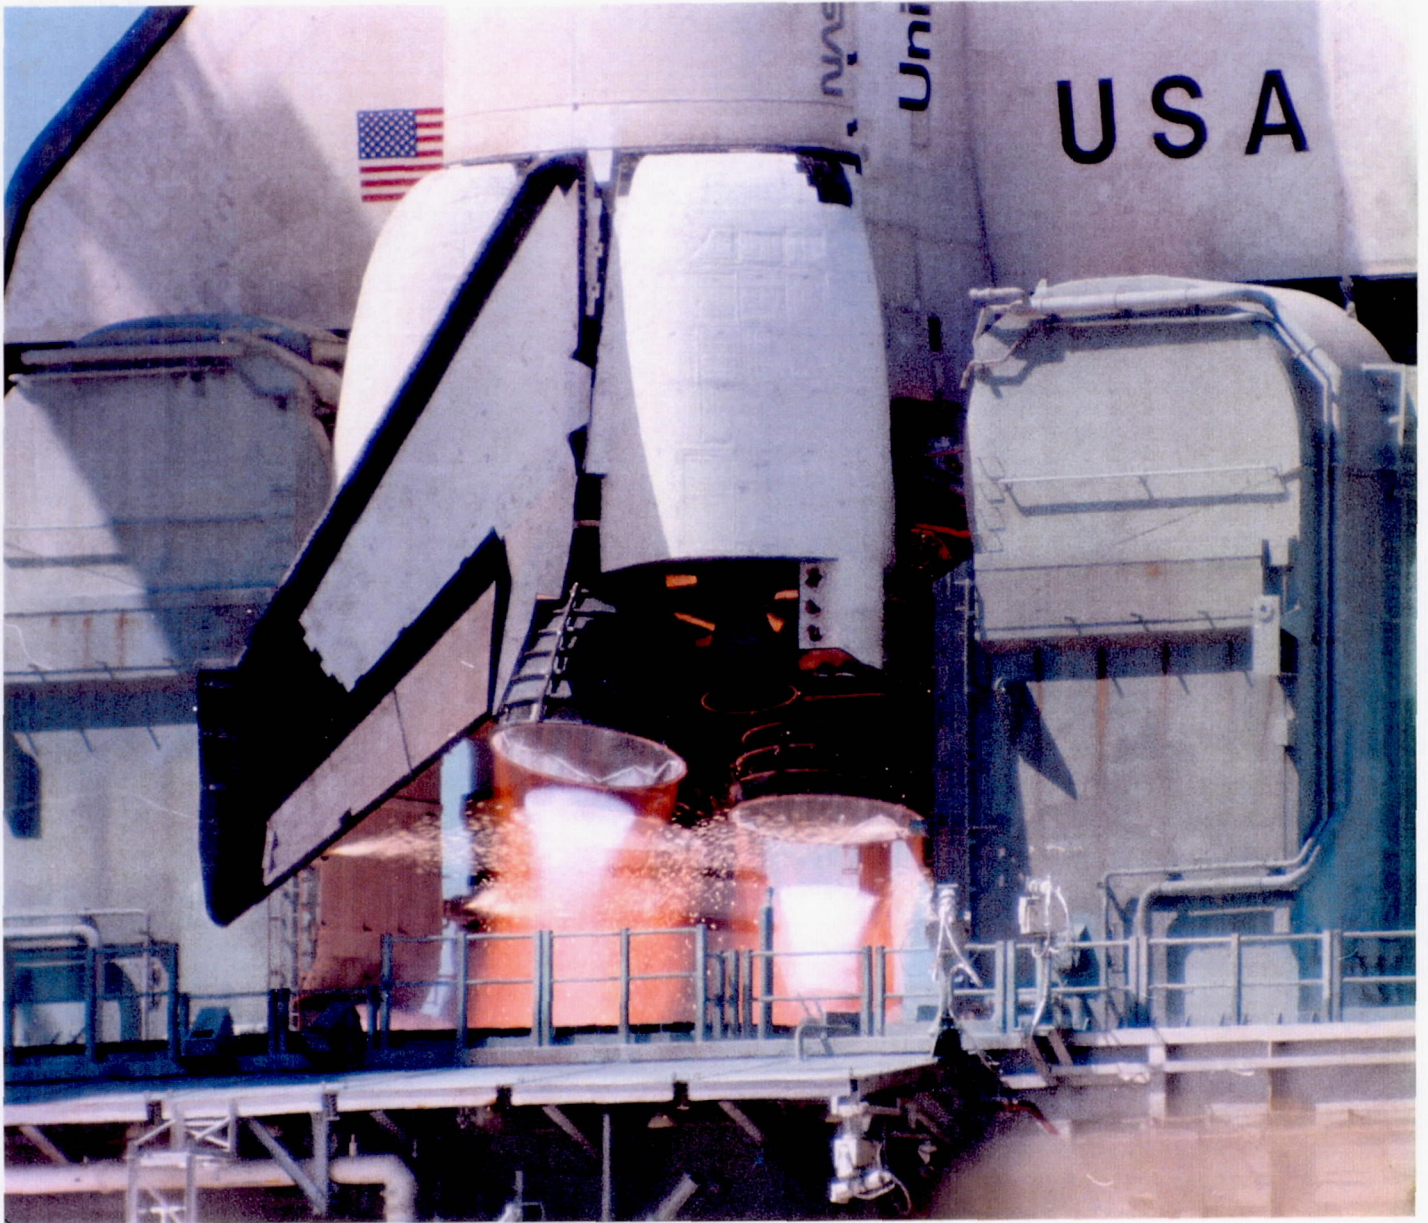
Photo 7: SSME Mach Diamonds Formed in a 3-1-2 Order

With the exception of Mach diamond formation (in the order 3-1-2), SSME ignition appeared normal (OTV-051, -070; E-19, -20, -76). Free burning hydrogen drifted up to the OMS pods. A flash in the SSME #2 Mach diamond during start-up may be indicative of a momentary contaminant in the fuel.

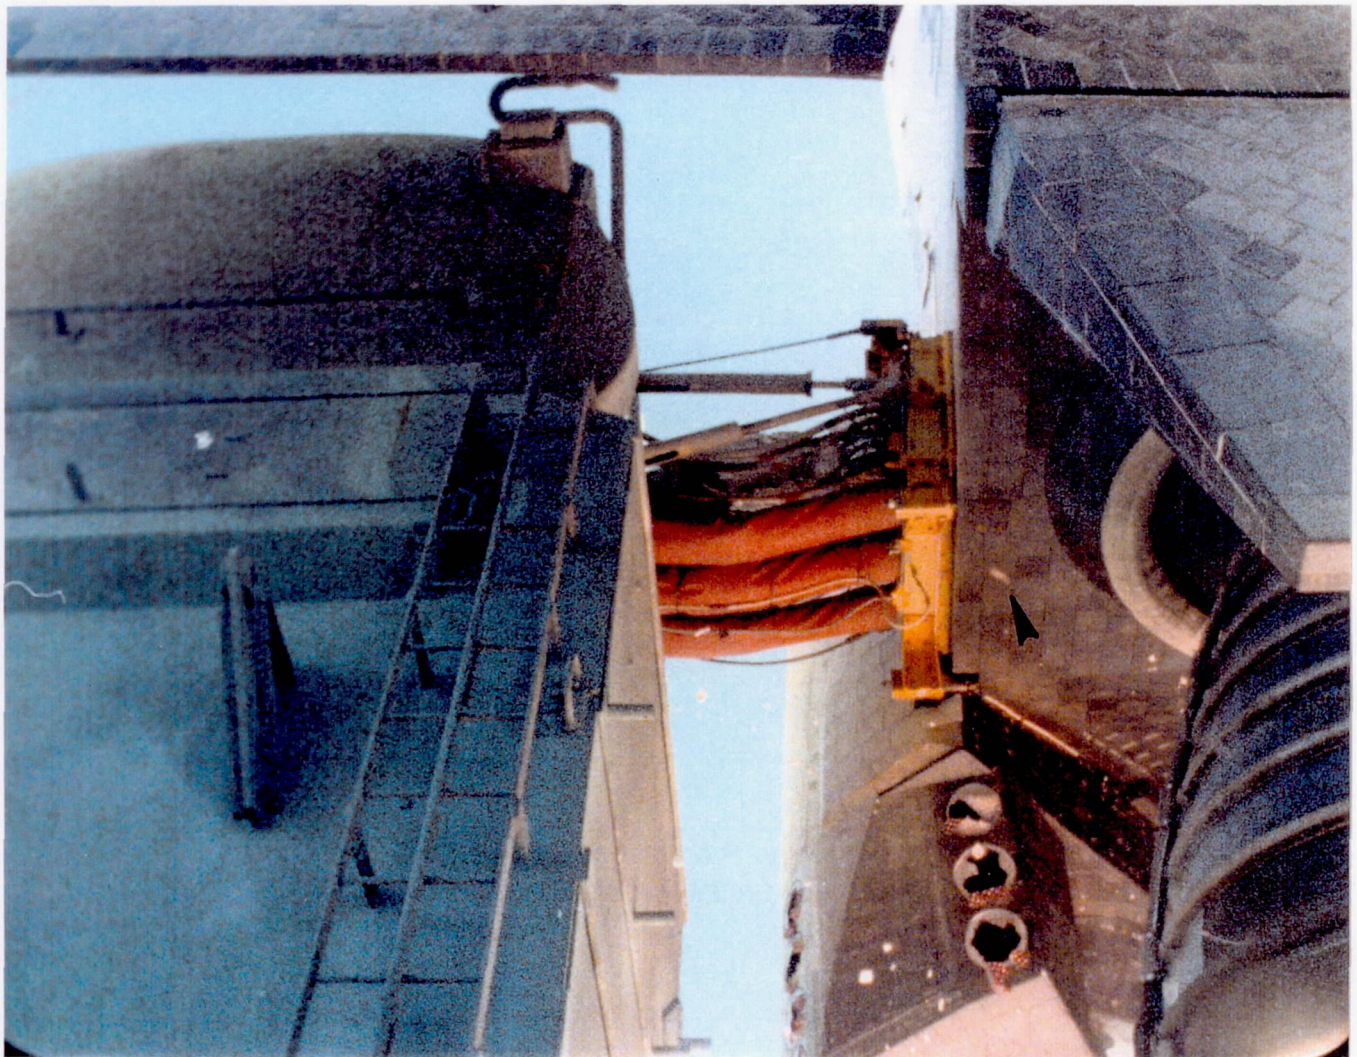
Photo 8: Tile Gap Filler

A thin, 5-inch long by 1-inch wide object appeared from the base heat shield area behind SSME #3 and fell aft at 19:20:29.416 UTC. The object was more flexible than a GSE tile shim and may have been a tile gap filler.

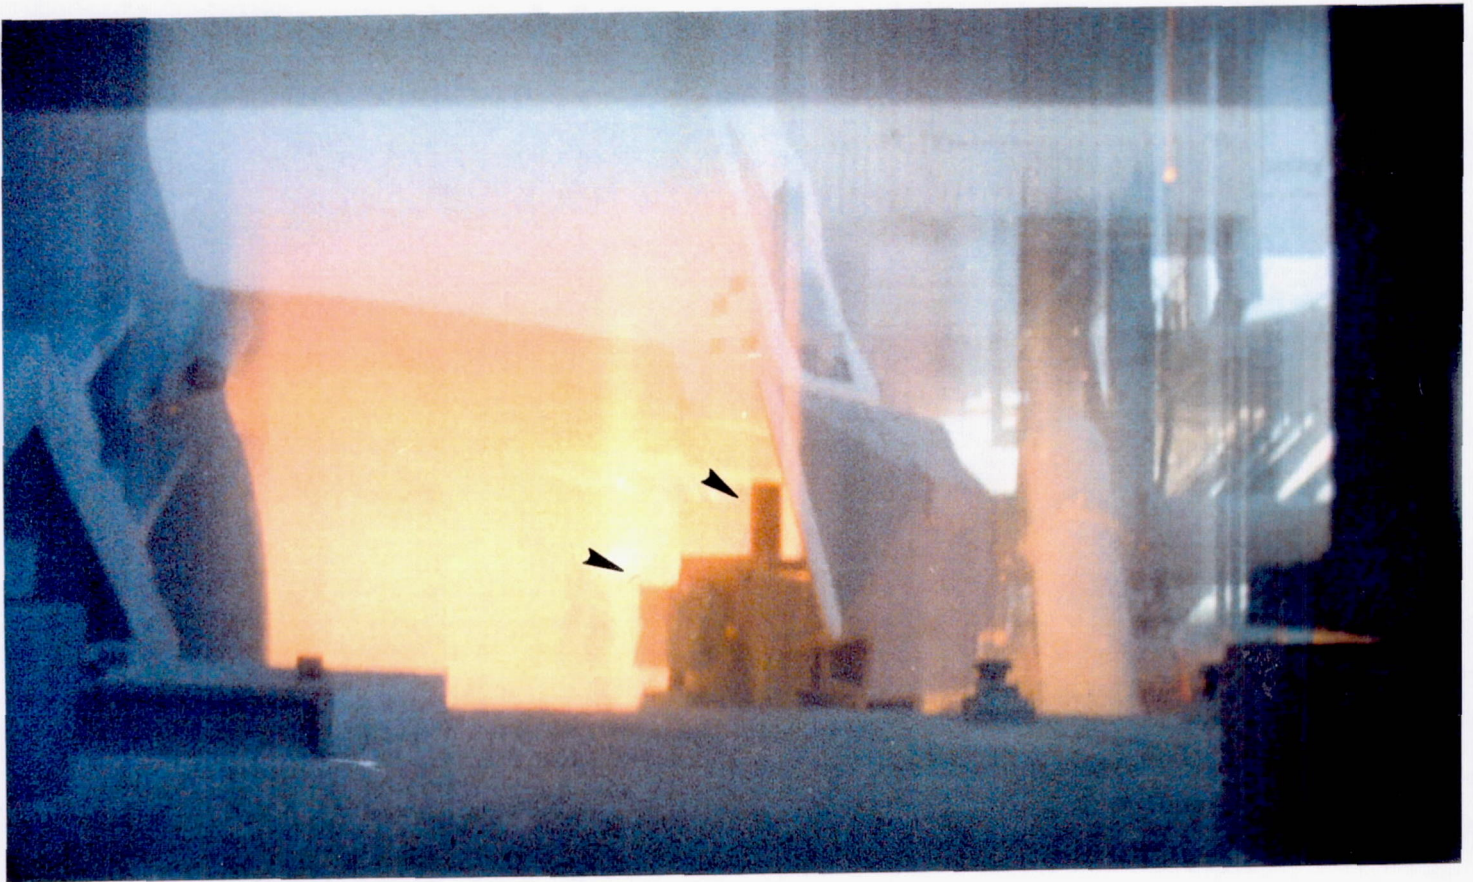
Photo 9: HDP #7 Stud Hang-Up

A stud hang-up occurred on HDP #7. A shaved piece of aluminum from the bore wall fell past the HDP shoe shortly after T-0. No stud hang-ups or frangible nut/ordnance debris was observed on any of the other holddown posts with the exception of a small fragment near the HDP #5 DCS.

Signs of a stud hang-up were evident on the HDP #7 foot with broaching of the bore wall. Stud thread impressions were also present in the wall. Two to four stud thread impressions were also detected in the #2, #3, #5, #6, and #8 bore walls. These thread impressions may have been created during the stacking/tensioning process.

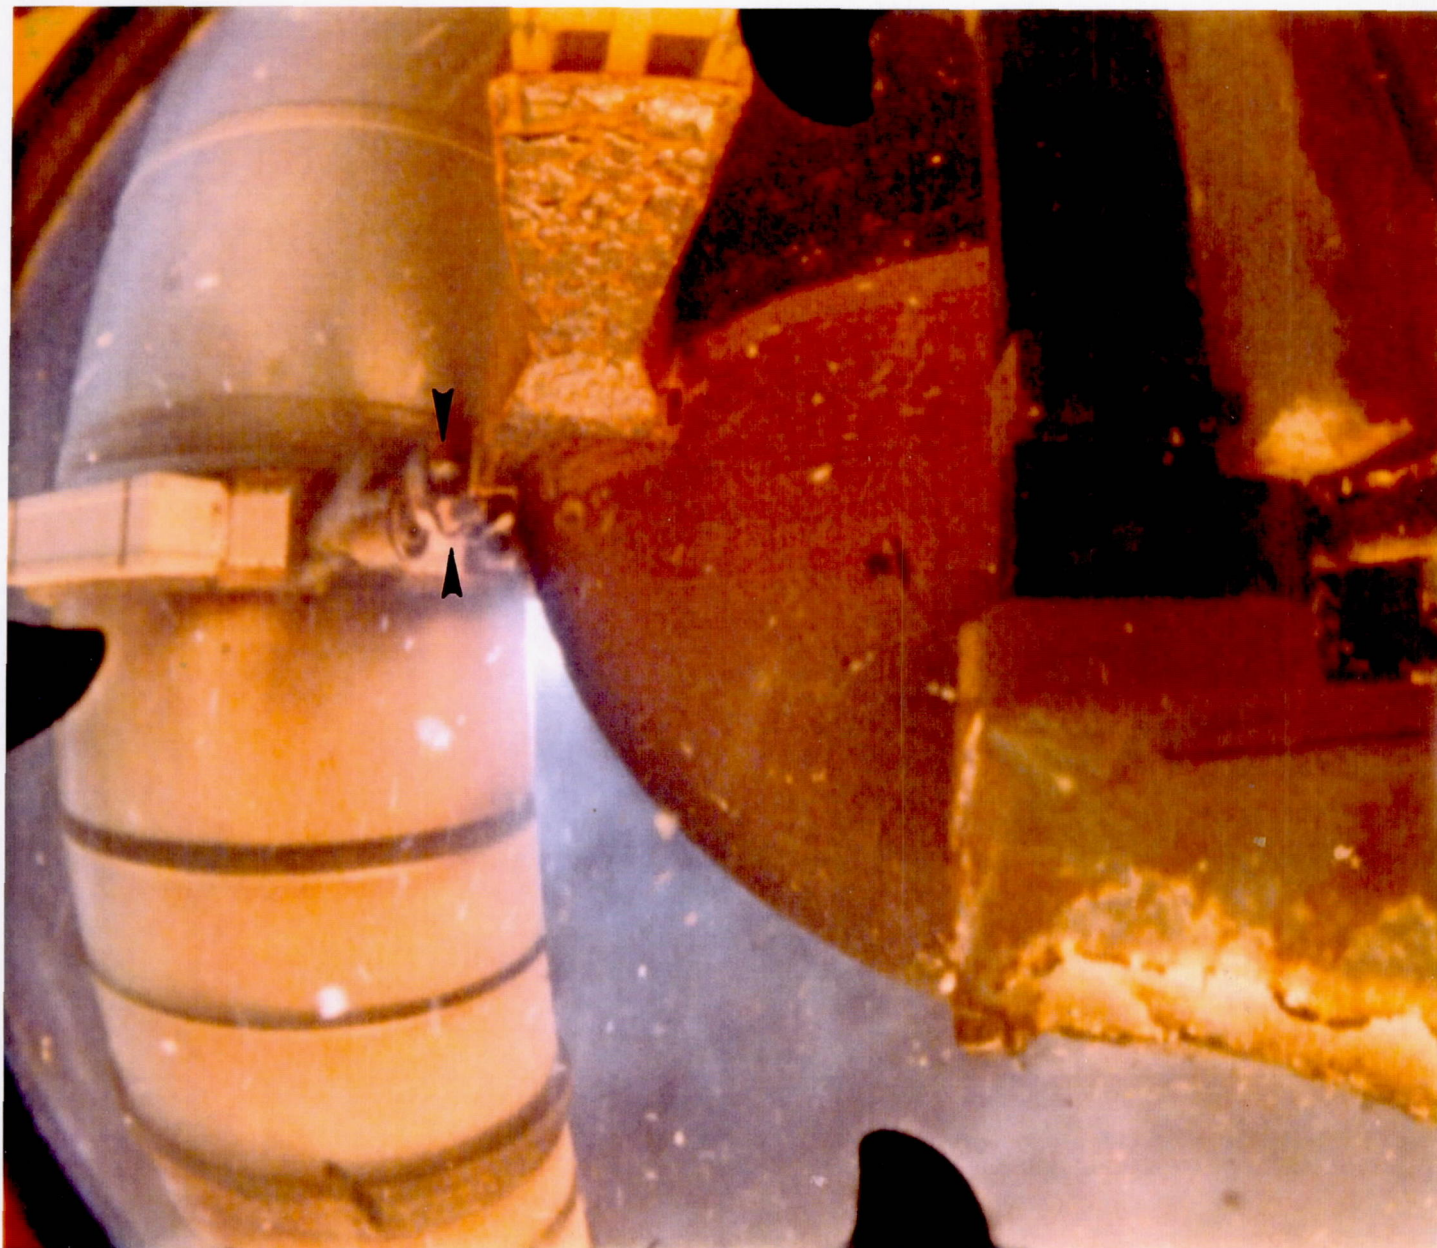
The -Y ET/SRB fairing splice plate closeout was missing a shallow, 3" x 2" area of foam.

The -Y thrust strut was missing 3-inch diameter areas of foam - one on the flange closeout and one just aft of the flange on the barrel.

Photo 11: Normal Separation of Left SRB from ET
Foam missing from the upper strut fairing closeouts left shallow divots

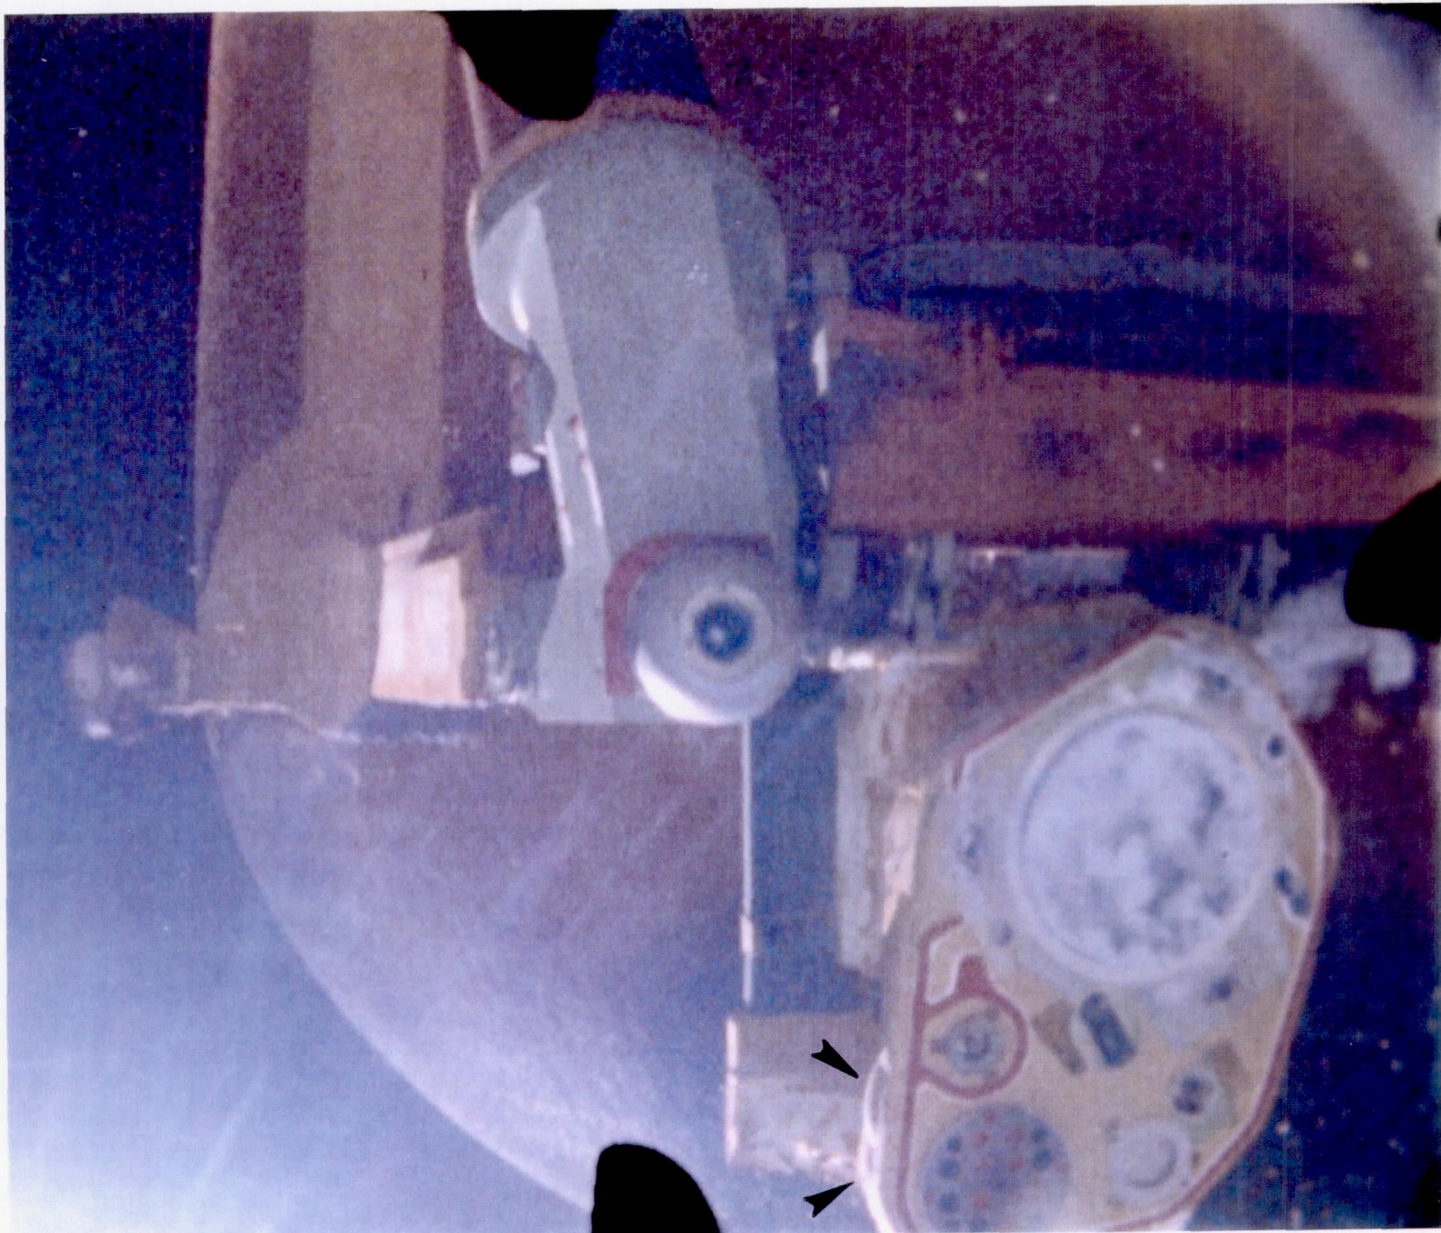
Photo 12: LH2 ET/ORB Umbilical

The LH2 ET/ORB umbilical appeared to be in good condition after separation with no TPS damage. Frozen hydrogen adhered to the 17-inch disconnect and parts of the separation interface. The fire barrier on the outboard side of the LH2 umbilical exhibited two unusually large bubbles that were estimated to be 3" x 2" and 6" x 2", respectively. Typically, foam had eroded from the horizontal (clamshell) section of the cable tray.

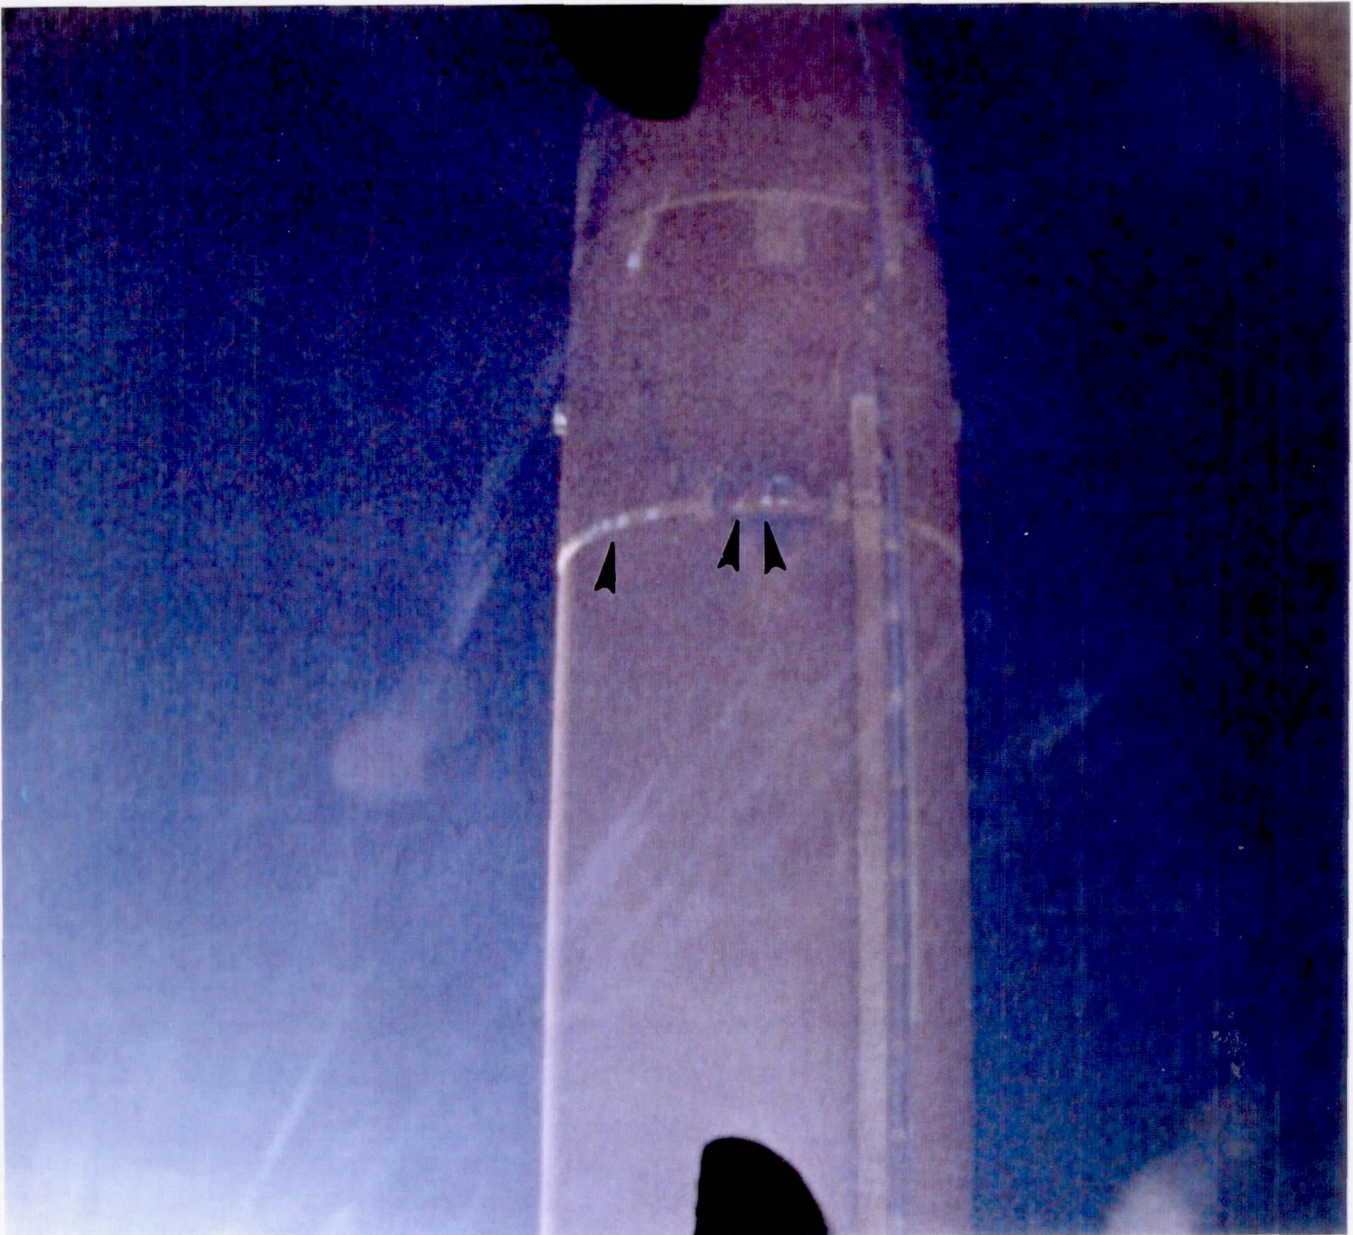
Photo 14: LH2 Tank-to-Intertank Flange Closeout Divots

Five TPS divots were visible in the intertank-to-LH2 tank flange closeout in the -Y+Z quadrant outboard of the -Y bipod housing. The divots spanned the entire width of the closeout (9-11 inch diameters), but were not deep enough to show shadow or primed substrate. Three more TPS divots were detected in the intertank-to-LH2 tank flange closeout between the bipods. Two of the divots were located close to centerline /+Z axis while the third divot appeared to be in the general area of the -Y bipod standoff closeout. These three divots were approximately 6-7 inches in diameter and shallow.

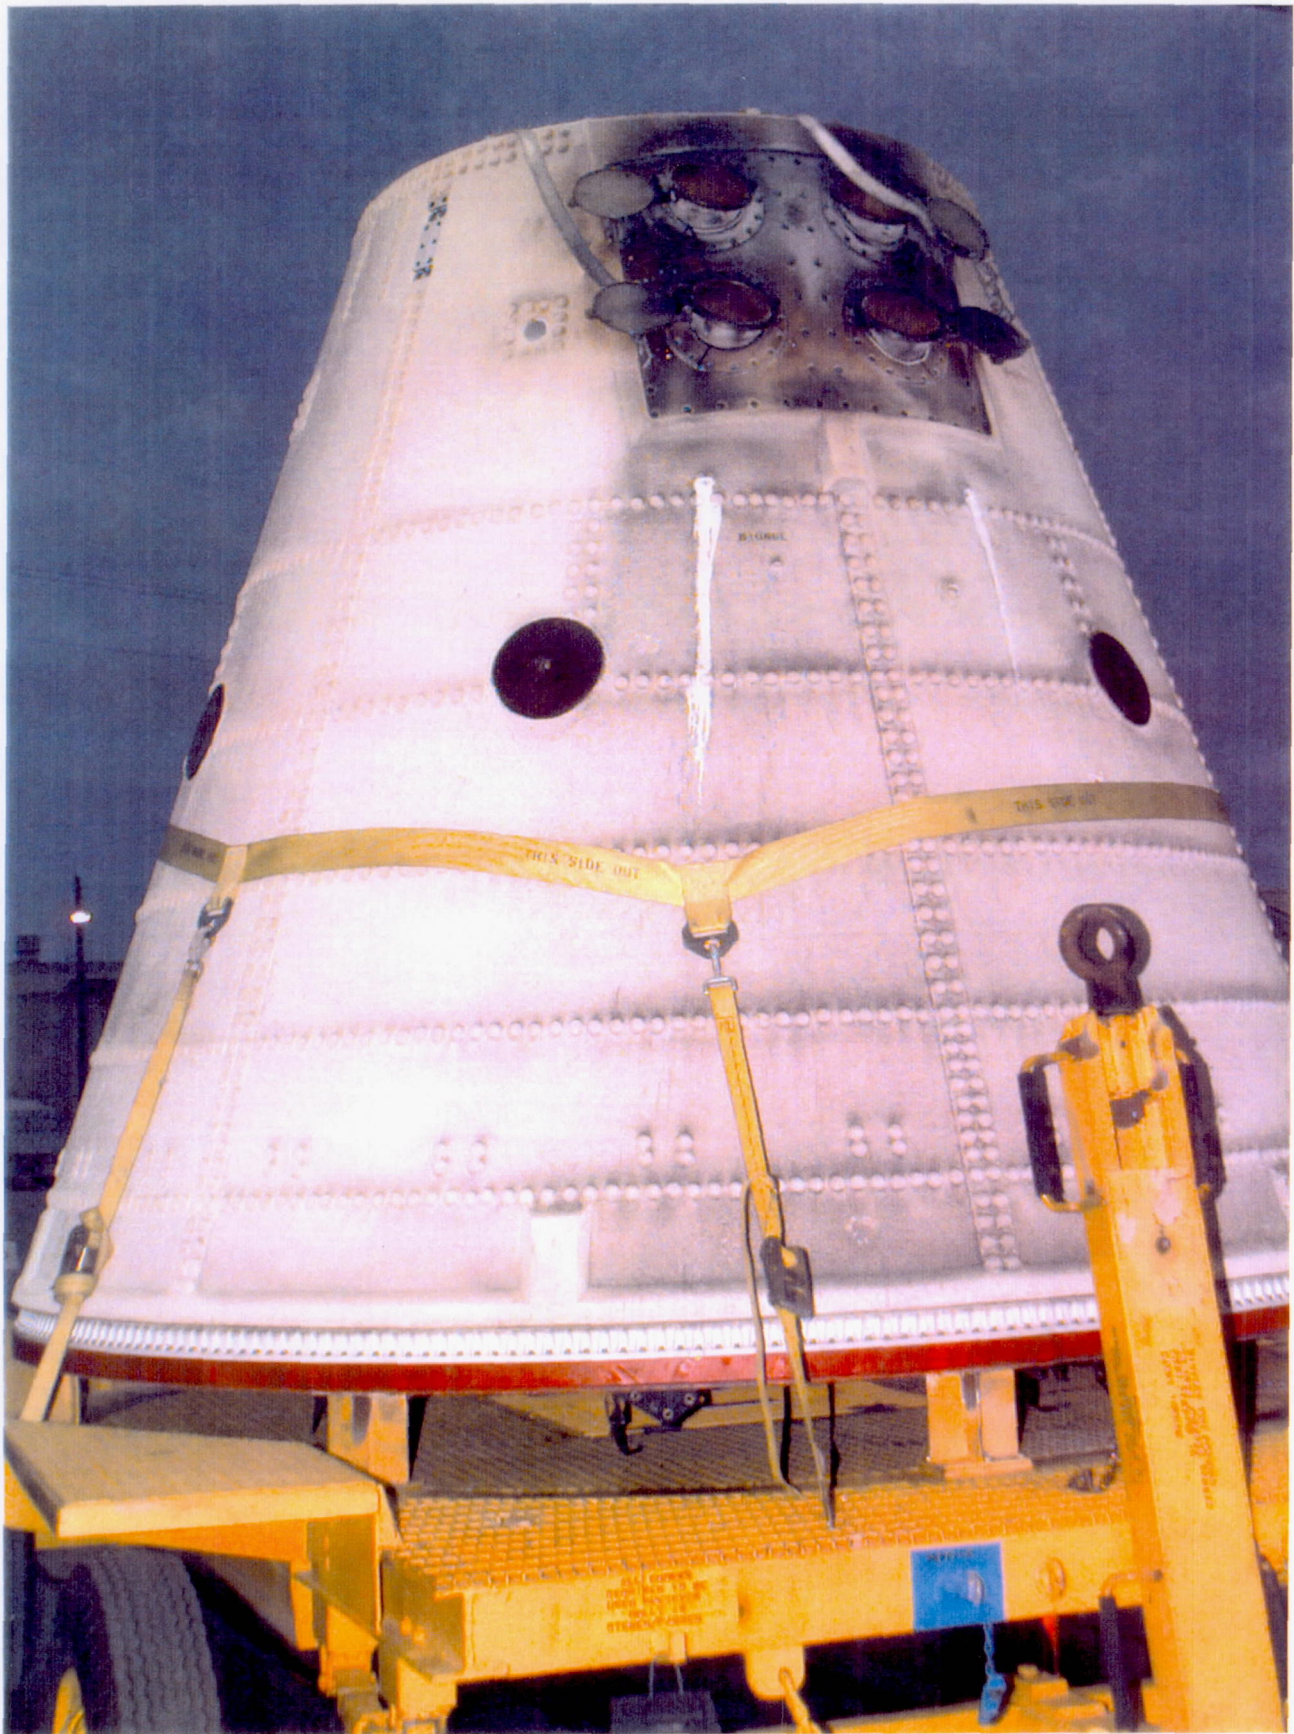
Photo 15: Left Frustum

The left frustum was in excellent condition. No TPS was missing and no debonds were detected over fasteners or acreage. None of the Hypalon paint had blistered. All four BSM aero heat shield covers appeared to be locked in the fully opened position.

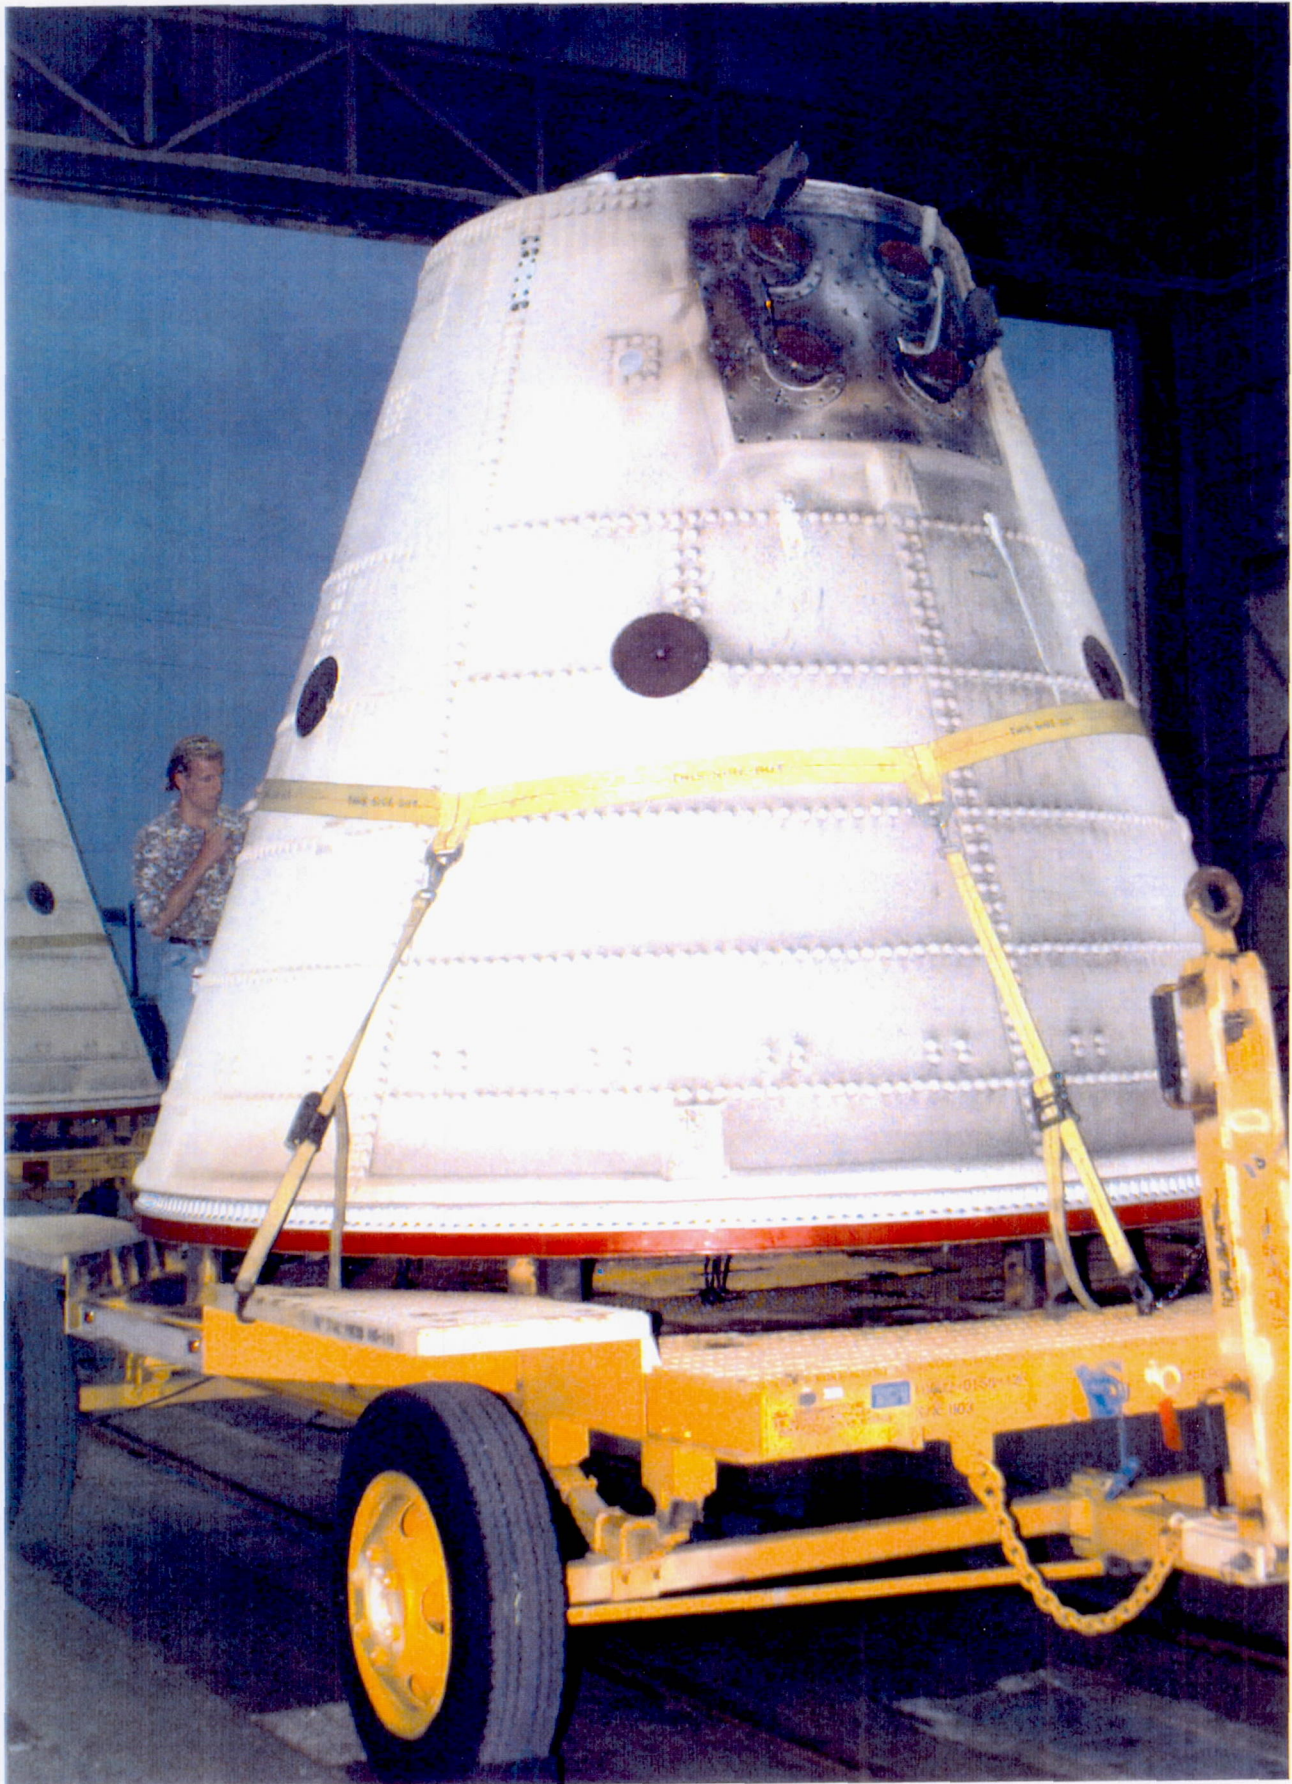
Photo 16: Right Frustum

The right frustum was in excellent condition. No TPS was missing and no debonds were detected over fasteners or acreage. None of the Hypalon paint had blistered.
